BUREAU OF SHIPS GROUP  
TECHNICAL INSPECTION REPORT.

U.S.S. BRACKEN (APA64)

TEST ABLE

# OPERATION CROSSROADS

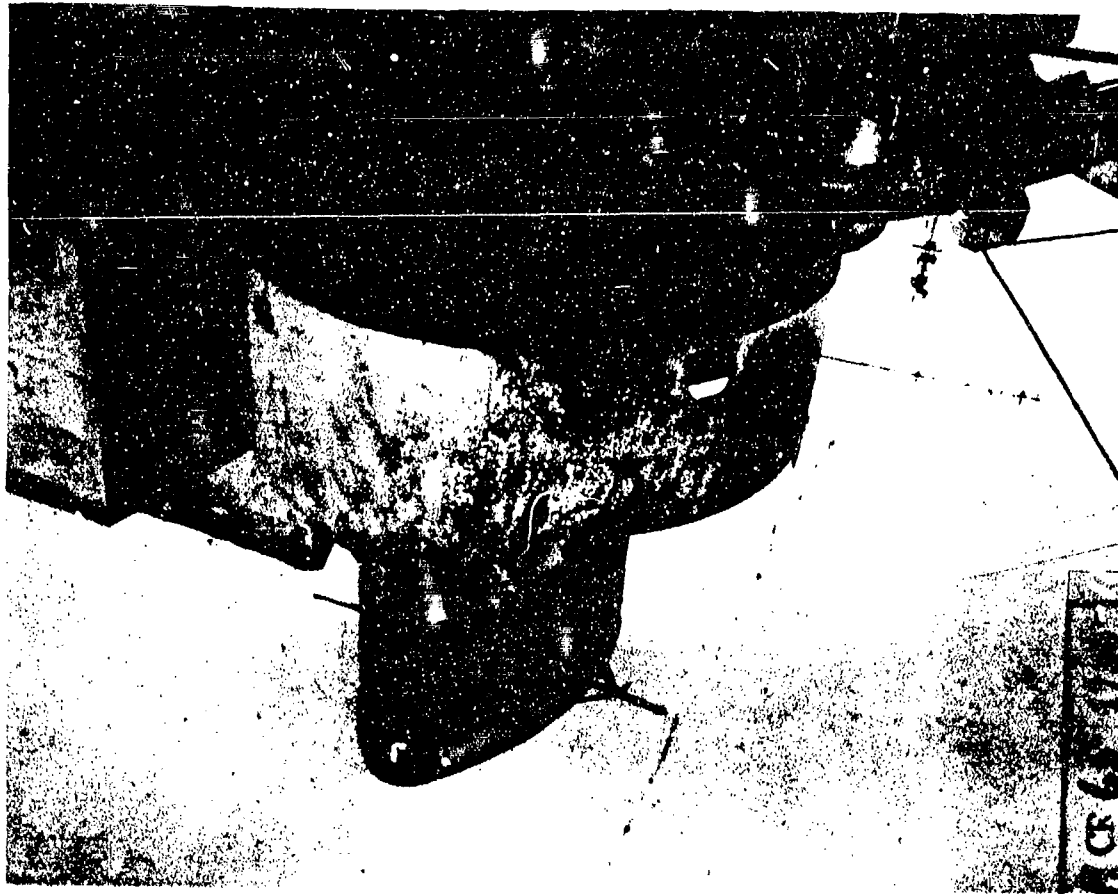
Damage is limited mainly to slight dishing of light plating (54 or less). This included the crumpling of the port flag bag, slight dishing of the after centerline flag bag, and the slight dishing of the after side of the projection bootin. (photo 1730-11, page 38). The glass in at least one sprinkler control station was shattered by the blast. An instrumentation mirror was shattered and wrecked. Vent screens in the stacks are pushed in.

Paint is blistered and scorched over large areas. This is noticeable principally on portions of the superstructure facing the blast and on port quarter of the foreboard. No blistering or scorching is found on any of the decks. Zinc chromate primer, formula 84, when exposed, seems to blister and scorch worse than the usual top coats. (Photos 1730-8, 10, 11; pages 34, 35, and 36) show typical damage to paint.

AA-CR-65-1730-11. After end of superstructure port showing paint blistering on gun shield and dished plating of projection booth.
